How to solve if Lonsdor K518ISE can't be connected to any supported car models

OBD test cable testing method:

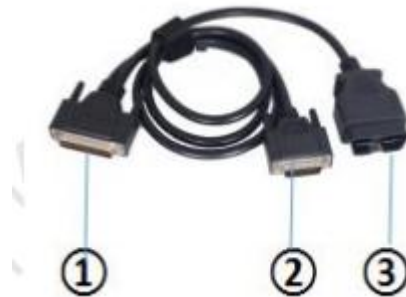
Pay attention that there are 3 connectors on the OBD cable:

Connector 1: connect K518ISE OBD port;

Connector 2: connect KPROG adaptor

Connector 3: connect the vehicle OBD port

Pic 1: 3 connectors on OBD cable

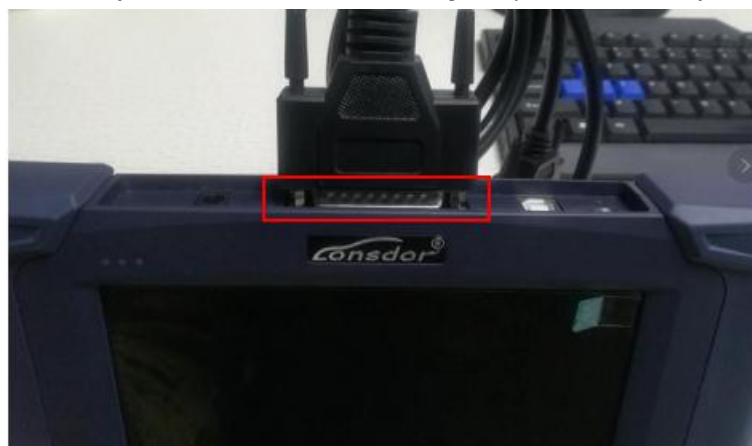
Step 3: Use the red pen to touch the **metal part**(as shown in pic 2 in red)

Pic 2: Metal part on K518ISE OBD port

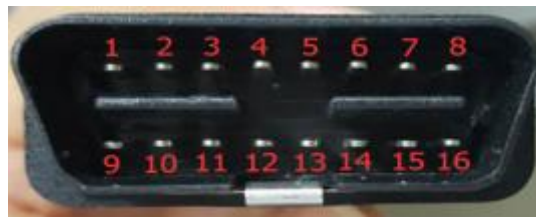
Step 4: Use the black pen to test the resistance of each pin of the vehicle connector (As shown in pic 3) , make sure that you hold the vehicle connector in the way just as the pic shows:

Pic 3: 16 pins on the vehicle OBD connector

PIN 1 and 8 should have no resistance; PIN2,3,4,5,6,7,9,10,11,12,13,14,15,16 should have resistance.

If all have no resistance, then it will be DB25 cable has problem; if the measurement is all as it supposed to be, and the car models(those K518ISE supported models) still can't be connected, then you will need to send back the DB25 cable and the main unit for Lonsdor to check(**if so, let us know, and we shall talk together about the solution and details**)
